# Corrosion and tribocorrosion performance degradation mechanism of multilayered graphite-like carbon (GLC) coatings under deep-sea immersion in the western Pacific

Corrosion evolution of Cr/GLC multilayered coating exposed in the deep sea of the western Pacific after 342 days at various depths was investigated. Results showed that the atomic structure of the top-layer GLC layer remained almost unchanged after immersion, but severe corrosion across multi-scaled interfaces was significantly stimulated as the immersion depth increased. This further led to the weakening of coating density and adhesion strength, with the wear rate and corrosion rate being two orders of magnitude larger than those of the as-deposited coating. Therefore, reducing defect density and conductivity is the key to designing GLC coatings for deep-sea applications.

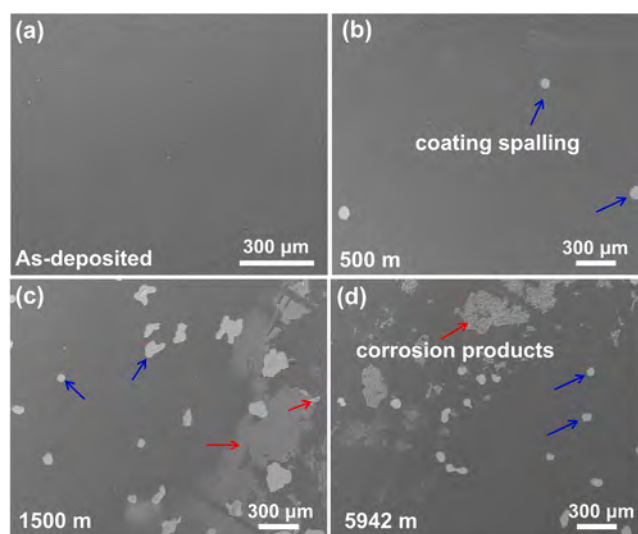
The surface corrosion morphologies of the as-deposited coating and the Cr/GLC multilayered coatings after immersion at different depths were observed under low magnification and a wide field of view, with the results shown in Fig. 4. The results from Fig. 4a show that the surface of the as-deposited sample is smooth, flat, and without any visible defects like delamination or cracks. However, the surface of the coated sample exhibits varying degrees of coating delamination after immersion. At a depth of 500 m, several approximately circular corroded regions with scales of 100–200  $\mu\text{m}$  became evident on the surface of the coating. This was accompanied by the onset of localized delamination, as indicated by the red arrows. After increasing the immersion depth to 1500 m, the corroded regions on the coating surface grew, leading to changes in their shape from nearly circular to irregular shapes that indicated the connected expansion of the corrosion areas. Upon further increasing the depth to 5942 m, localized corrosion and delamination

Fig. 4. Corrosion morphologies of Cr/GLC multilayered coating before and after exposure in different depths at Pacific Ocean.

phenomena were similarly pronounced, and corrosion products began accumulating on the coating surface. Macroscopic surface corrosion morphologies indicated that coatings suffered significant corrosion at different immersion depths. In addition, as the depth of immersion increased, the occurrence of localized delamination and the outward diffusion of corrosion products on the surface of the coating became more pronounced.

The surface of the sample exposed to 5942 m shown in Fig. 4d presented various corrosion features such as localized corrosion at coating defects, coating delamination and substrate corrosion. Therefore, SEM and EDS were employed to further characterize and analyze the surface corrosion morphology and composition of the coatings. This approach aims to clarify the corrosion pathways and mechanisms of Cr/GLC multilayered coatings in deep sea environments.

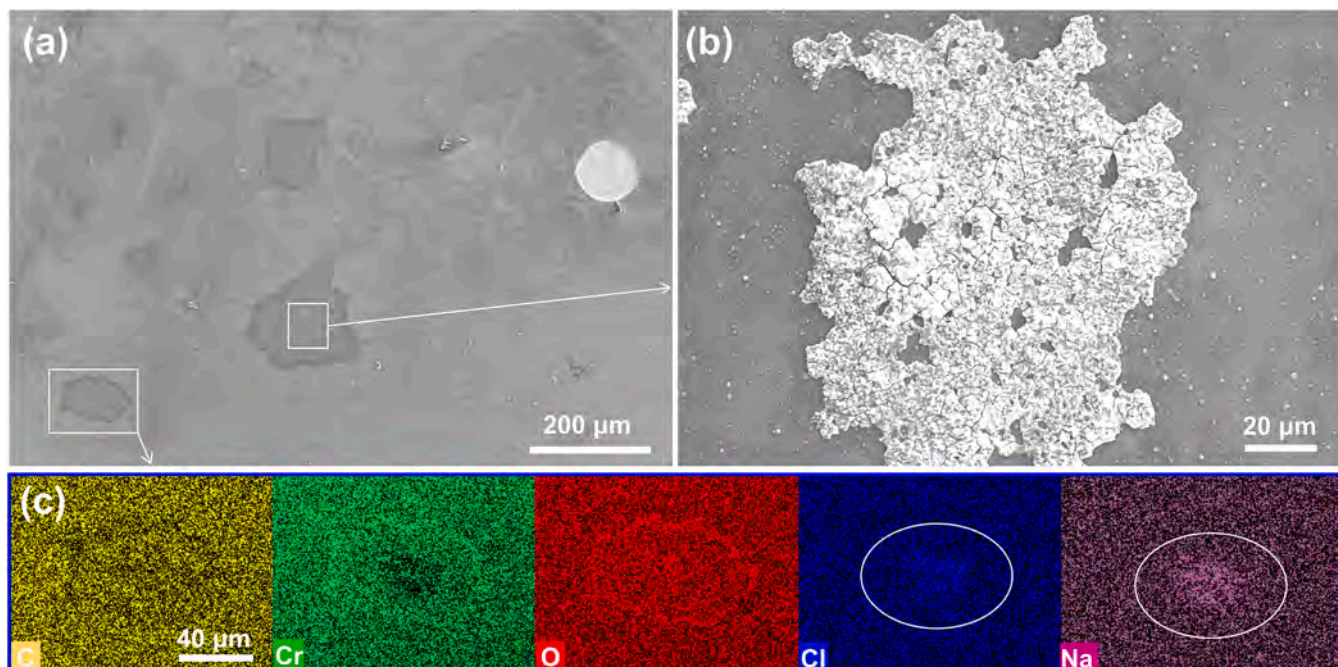
Fig. 5 illustrates the typical localized spalling and several site of infiltration-corrosion morphology. Fig. 5b highlights the corrosion byproducts that are centered in the infiltrated area. Fig. 5c provides EDS mapping data derived from the region depicted in Fig. 5a. Due to the use of a backscattered electron-excited secondary electron mode, the morphology image presents both surface characteristics and information regarding elemental contrast. The dark areas in the morphology image do not display considerable structural alterations and are thus assumed to be the differences in elements. Furthermore, using an electron beam acceleration voltage of 20 kV, backscattered electrons can penetrate to the micron scale, suggesting that the contrast information could come from the interface at the base of the coating. Spectral analysis indicates significant enrichment of oxygen (O) and chromium (Cr) elements in both the central and peripheral regions of the dark area. Concurrently, the enrichment of Cl and Na elements is particularly noticeable at the center of the dark area. These characteristics indicate that, under the influence of hydrostatic pressure, seawater infiltrates the micro-defects in the coating, leading to corrosion at the interface between the coating and the substrate.

Fig. 5. The infiltration-corrosion morphology and EDS mapping results of Cr/GLC multilayered coating after immersion at 5942 m.

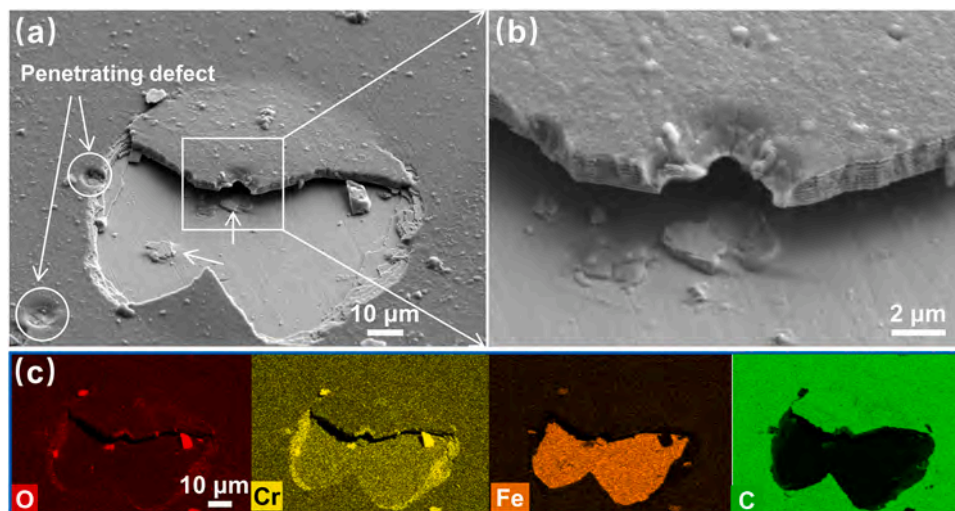
Fig. 6 illustrates a typical corrosion morphology that presents a localized spalling of the coating. The bottom of the spalled area is generally smooth, with a particular protrusion located at the center (highlighted by the white arrow). Two common penetrating defects are visible within the un-spalled section of the coating and on the left edge of the delamination. The edges of this area show noticeable indications of layered delamination, suggesting that corrosion is not restricted to the interface between the substrate and the Cr layer. Rather, it also transpires between the intermediate layers of Cr/GLC. The corrosion amongst the layers reduces the bonding strength and leads to the occurrence of the layered delamination phenomenon. This observation highlights that the process of penetration-corrosion may take place at the interface of the topmost Cr/GLC layers, as evidenced by the observed enrichment of oxygen (O) and chromium (Cr) elements. Fig. 6b showed a raised portion at the bottom of the penetrating defect, aligning with our prior research on defect formation. EDS mapping results (Fig. 6c) suggested that the defect fully exposed the substrate material, thereby allowing seawater to directly access the substrate through this pathway under hydrostatic pressure. Consequently, corrosion reactions would occur simultaneously within both the substrate material and the Cr layer. This feature of corrosion delamination indicates that the corrosion process initiates at the surface from localized penetrating defects, which then corrode preferentially at the interface in the substrate region. This progression ultimately leads to the gradual detachment of the coating around the penetrating defects. This explanation explains the nearly circular spalling morphology observed in the microscopy images shown in Fig. 4.

Fig. 6. (a-b) The local spalling of coating corrosion morphologies of Cr/GLC multilayered coating after immersion at 5942 m, (c) the corresponding EDS mapping results from (a).

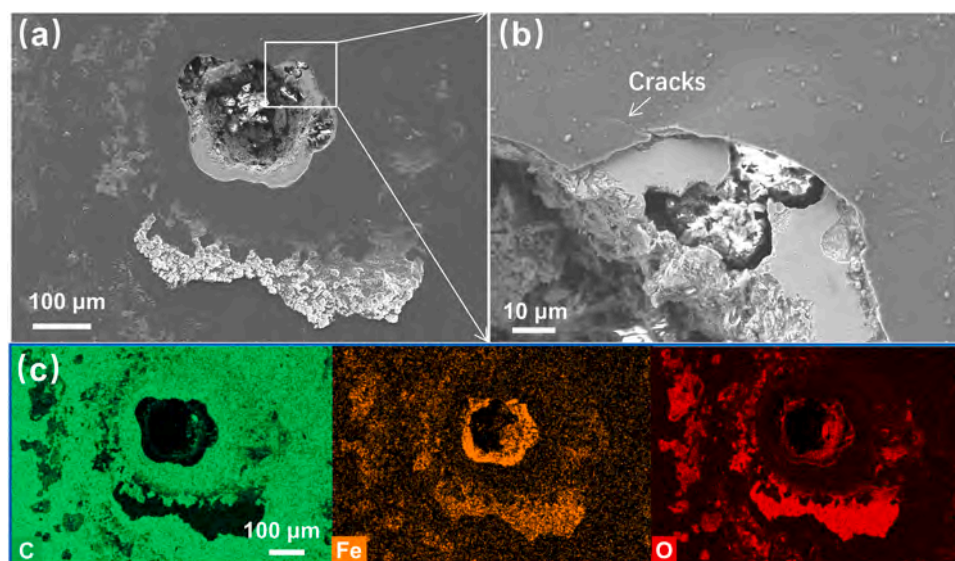
Severe localized corrosion on the coating surface, together with the corresponding EDS mapping results, is shown in Fig. 7. The corrosion morphology reveals pronounced corrosion beneath the delaminated coating. The EDS results indicate the diffusion and deposition of corrosion products, predominantly iron oxides, around the corroded pit. The magnified view depicted in Fig. 7b reveals significant substrate corrosion at the edge of the corroded pit, along with prominent coating cracking attributed to substrate/Cr interface corrosion. 17-4PH, being a precipitation-hardened martensitic stainless steel with numerous metallurgical carbide precipitates such as NbC and  $\epsilon$ -Cu, is susceptible to notable localized corrosion due to the potential difference between these precipitates and the surrounding matrix[21]. Delamination results in the

Fig. 7. (a-b) The severe localized corrosion morphologies of Cr/GLC multilayered coating after immersion at 5942 m, (c) the corresponding EDS mapping results from (a).

loss of the protective effect of the coating on the substrate and the resultant corrosion is primarily within the substrate. The products of localized substrate corrosion reactions cause pressure on the coating, causing it to crack and delaminate. Consequently, in the early stages of corrosion, interface corrosion dominates, leading to initial coating spalling and a significant increase in the exposed substrate area. After the distinctive organizational traits of the substrate, notable localized corrosion ensues. This event marks the commencement of coating delamination failure, with the accumulation and diffusion of substrate corrosion products serving as the main cause.

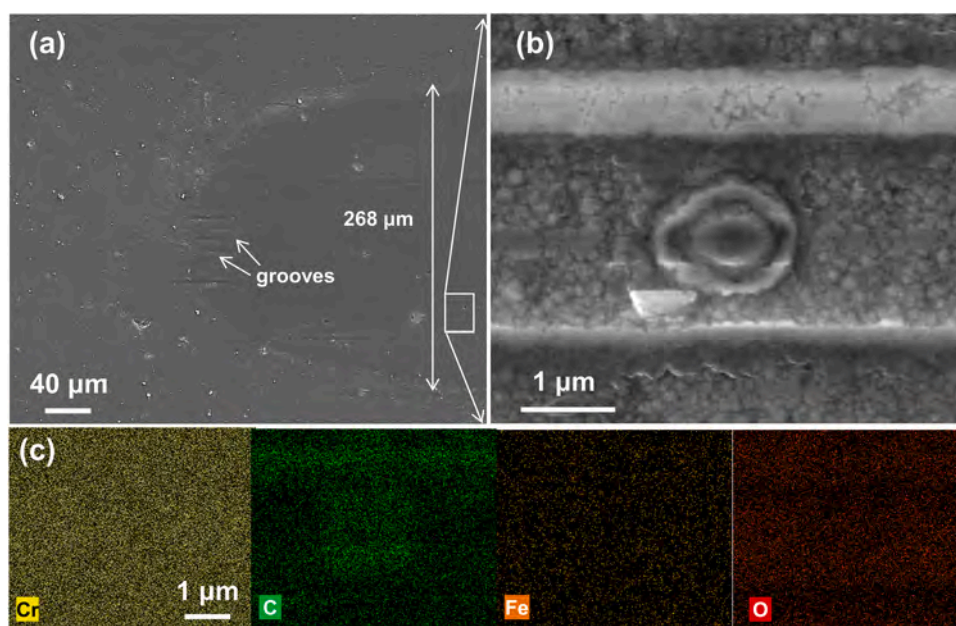
Fig. 10. The wear track morphologies (a-b) and (c) EDS mapping results of the as-deposited Cr/GLC multilayered coating after sliding test.

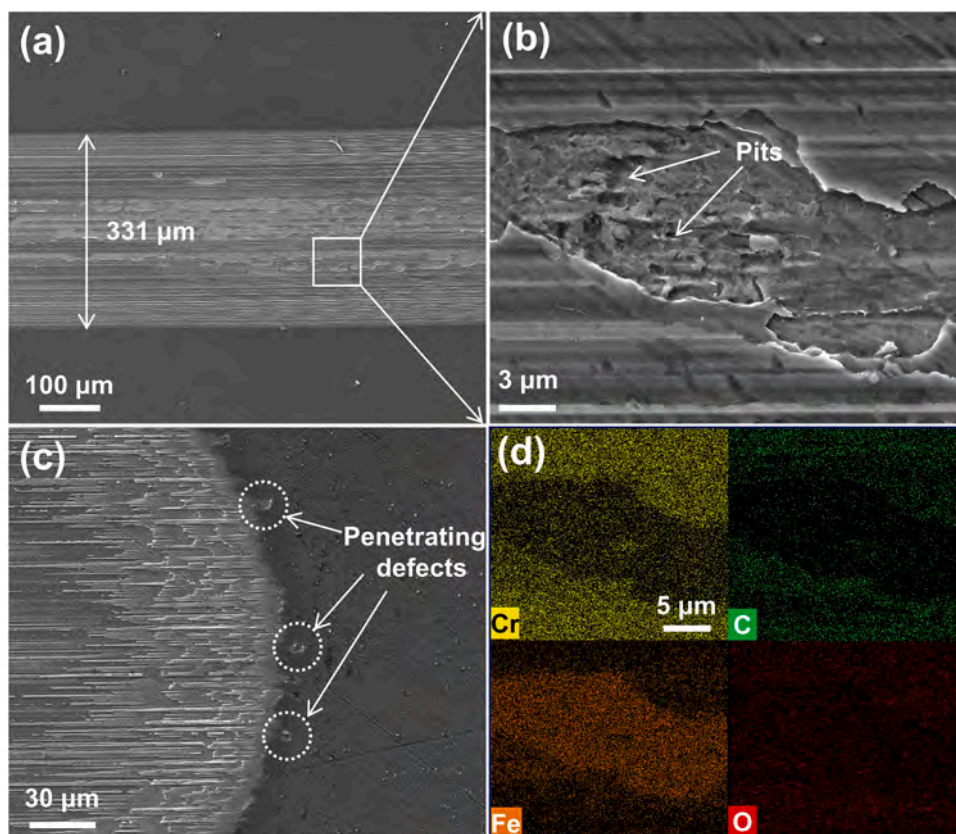
**Fig. 11.** The wear track morphologies of the Cr/GLC multilayered coating immersed at 500 m depth (a-c), the corresponding EDS mapping results from wear track (d).

wear track of 331  $\mu\text{m}$  in width, with prominent wear features oriented parallel to the sliding direction. Detailed examination of the base of the wear track (Fig. 11b) and EDS analysis reveals central delamination within the base region of the coating, leaving remnants of the Cr layer at the margin. Close inspection of the delaminated region reveals that the exposed stainless-steel substrate is no longer smooth but riddled with numerous pits. Obviously, these localized pits are not the result of friction and must be attributed to severe interfacial corrosion that has occurred at this specific location within the coating. During immersion, seawater infiltrates the substrate-coating interface through defects, initiating interfacial corrosion and consequently compromising the adhesion of the coating. This in turn makes the coating highly susceptible to delamination at the interfacial corrosion site during frictional sliding, as proved by the pronounced delamination features at the bottom of the wear profile. In addition, at the edges of the wear track (as shown in Fig. 11c), the coating exhibits noticeable delamination during the frictional delamination process, accompanied by obvious through-thickness defects, indicating that these defect locations are areas of weakened coating adhesion. The frictional process rapidly leads to failure of the coating delamination at these locations, resulting in an increase in the coefficient of friction and the rate of wear. This friction morphology also illustrates that the short-term increase in OCP during the early stages of sliding is due to the filling effect resulting from coating delamination [26,27].

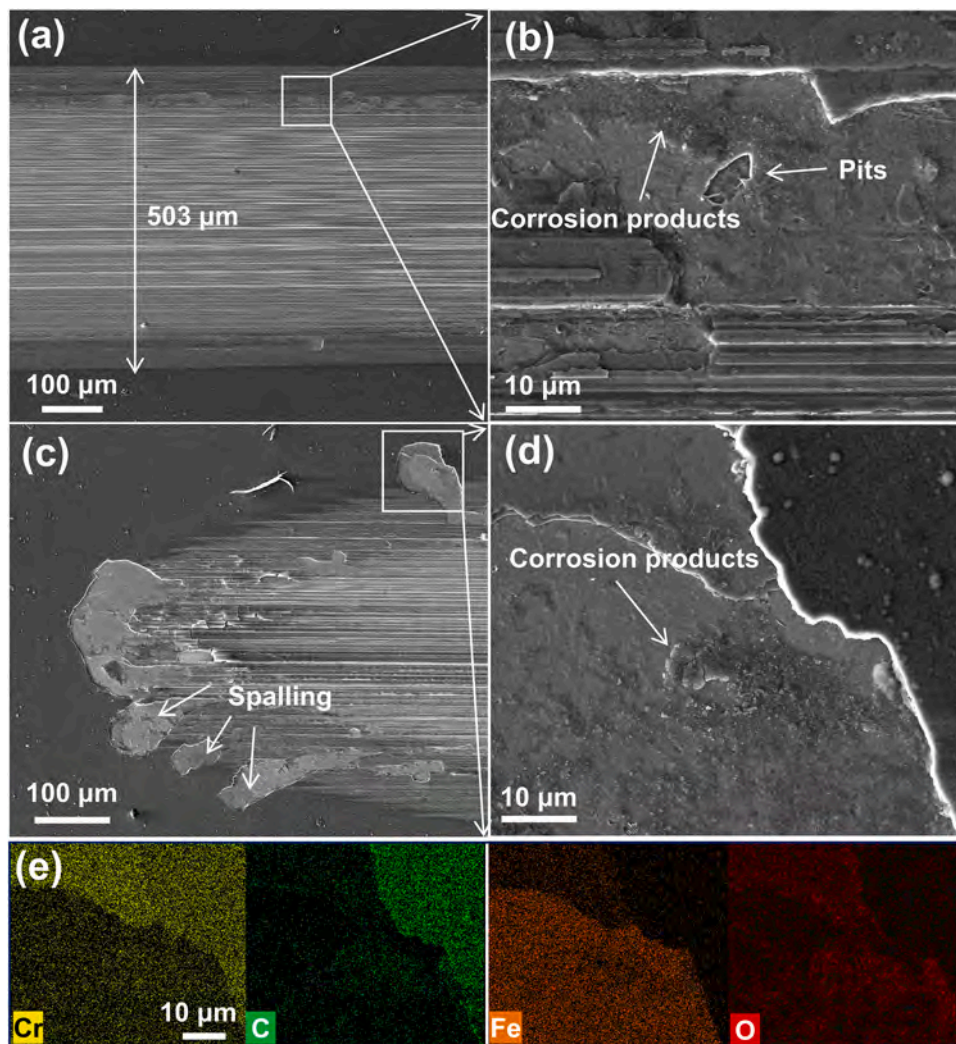
Fig. 12 displays the wear profile and elemental distribution of the coating sample following immersion at a depth of 1500 m. As shown in Fig. 12a, the wear width measures 503  $\mu\text{m}$ , while the wear depth is 5  $\mu\text{m}$ . Compared to earlier cases, the bottom of the wear track shows numerous grooves oriented parallel to the sliding direction, and there are noticeable localized delamination phenomena at the edges of the wear track. A thorough inspection of the delamination occurring at the edges of the wear track reveals remarkable interfacial corrosion characteristics. The

accumulation of corrosion products at the interface impairs the adhesive strength of the coating, leading to gradual delamination during the friction process. It is worth mentioning that Fig. 12c illustrates a considerably extensive delamination region at the edges of the wear track. Analysis of the delamination region at the edges of the wear track (Fig. 12d) indicates distinct layering delamination characteristics. In combination with the EDS results, a significant accumulation of corrosion products is observed at the stainless steel/Cr buffer layer interface. Despite not being part of the frictional contact area, the extensive delamination present in this region indicates severe multi-interface corrosion, which significantly compromises the adhesion of the coating. As this sample demonstrates the maximum wear depth, its wear rate also reaches its highest value.

**Fig. 12.** The wear track morphologies of the Cr/GLC multilayered coating immersed at 1500 m depth (a-d), the corresponding EDS mapping results from wear track (e).

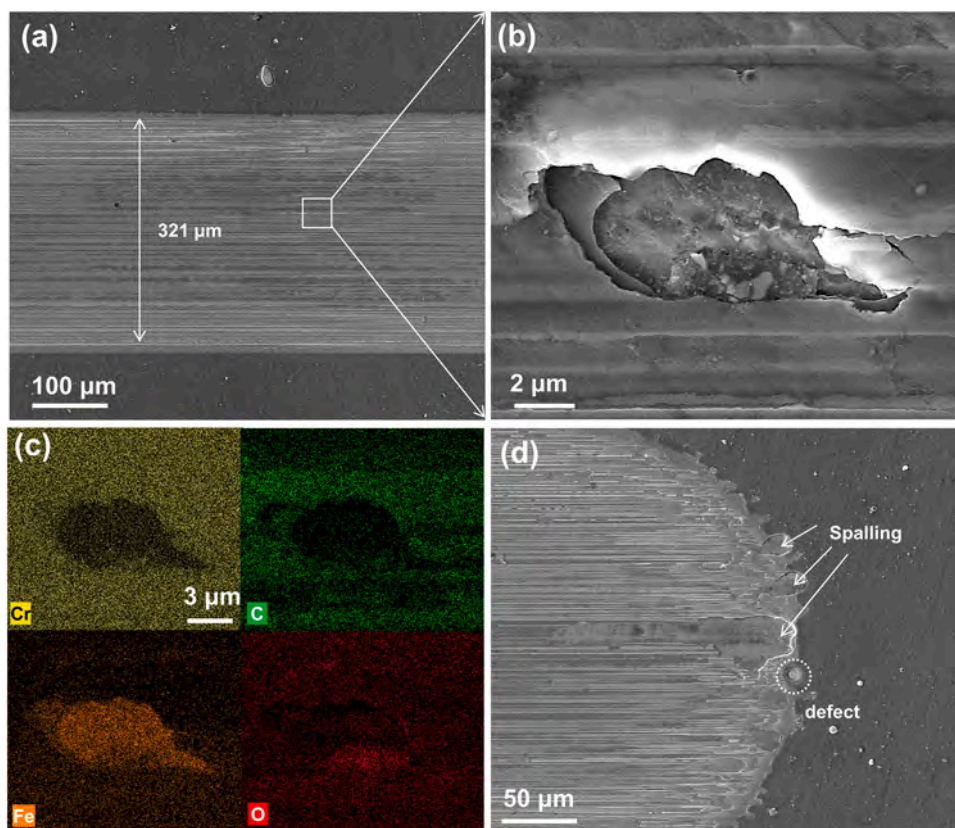
Following immersion at a depth of 5942 m, the wear profile of the coating sample is shown in Fig. 13 with a measured width of 321  $\mu\text{m}$ . Significant delamination in the bottom of the wear track is observed. Combined with the microscopic morphology and EDS mapping results (Fig. 13b-c), the bottom of the coating shows obvious corrosion product accumulation and cracking, indicating that corrosion has occurred at this location. And similar localized defective corrosion and spalling phenomena also existed at the end of the wear mark (Fig. 13d). Notably, these morphological features resemble those of coating samples subjected to immersion at other depths, displaying a similar delamination failure mode resulting from interfacial corrosion damage.

**Fig. 13.** The wear track morphologies of the Cr/GLC multilayered coating immersed at 5942 m depth (a-b), (c) the corresponding EDS mapping results from wear track (b), (d) the wear track morphologies at the end of the track.

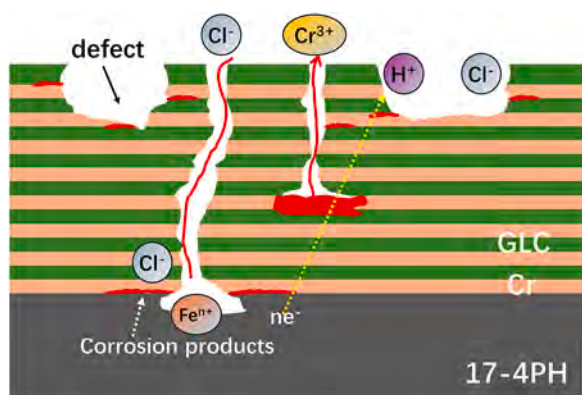
exposed substrate material serves as the anode. Therefore, a galvanic couple is formed between the GLC-Cr layer or the GLC-substrate in the multilayered Cr/GLC coatings. It has been confirmed that deep-sea hydrostatic pressure has a significant effect on the corrosion of the galvanic. Ma's research found that, with the increase of hydrostatic pressure, the corrosion current of the anode Al in the Al/Fe galvanic couple pairs increased significantly, and the hydrostatic pressure can accelerate the corrosion process of the anode in the galvanic couple pairs [32]. Hu's results also confirm that the hydrostatic pressure can promote the corrosion process of the anode material in the galvanic coupling pairs [33]. Our recent research further confirmed that hydrostatic pressure promotes Cl<sup>-</sup> adsorption on the coating surface, which together promotes dissolution of the metal-transition Cr layer and the metal substrate [17]. Therefore, in the Cr/GLC multilayered coatings, the GLC layer is protected as the cathode while the metallic Cr layer or the exposed substrate material acts as the anode and undergoes continuous corrosion. According to the localized corrosion process, the interface galvanic corrosion failure mechanism of Cr/GLC coating under hydrostatic pressure condition is shown in Fig. 14. The possible reactions that may take place at the Cr layer and GLC are as follows:

Because the GLC-Cr galvanic coupling corrosion occurs at the coating defect location, the anodic process on the GLC layer and the cathodic process on the metal layer are negligible, namely only the cathodic reaction occurring on the GLC, while only the anodic reaction occurs on

Fig. 14. The failure mechanism of Cr/GLC coating under hydrostatic pressure condition.
