# Corrosion and tribocorrosion performance degradation mechanism of multilayered graphite-like carbon (GLC) coatings under deep-sea immersion in the western Pacific

Corrosion evolution of Cr/GLC multilayered coating exposed in the deep sea of the western Pacific after 342 days at various depths was investigated. Results showed that the atomic structure of the top-layer GLC layer remained almost unchanged after immersion, but severe corrosion across multi-scaled interfaces was significantly stimulated as the immersion depth increased. This further led to the weakening of coating density and adhesion strength, with the wear rate and corrosion rate being two orders of magnitude larger than those of the as-deposited coating. Therefore, reducing defect density and conductivity is the key to designing GLC coatings for deep-sea applications.

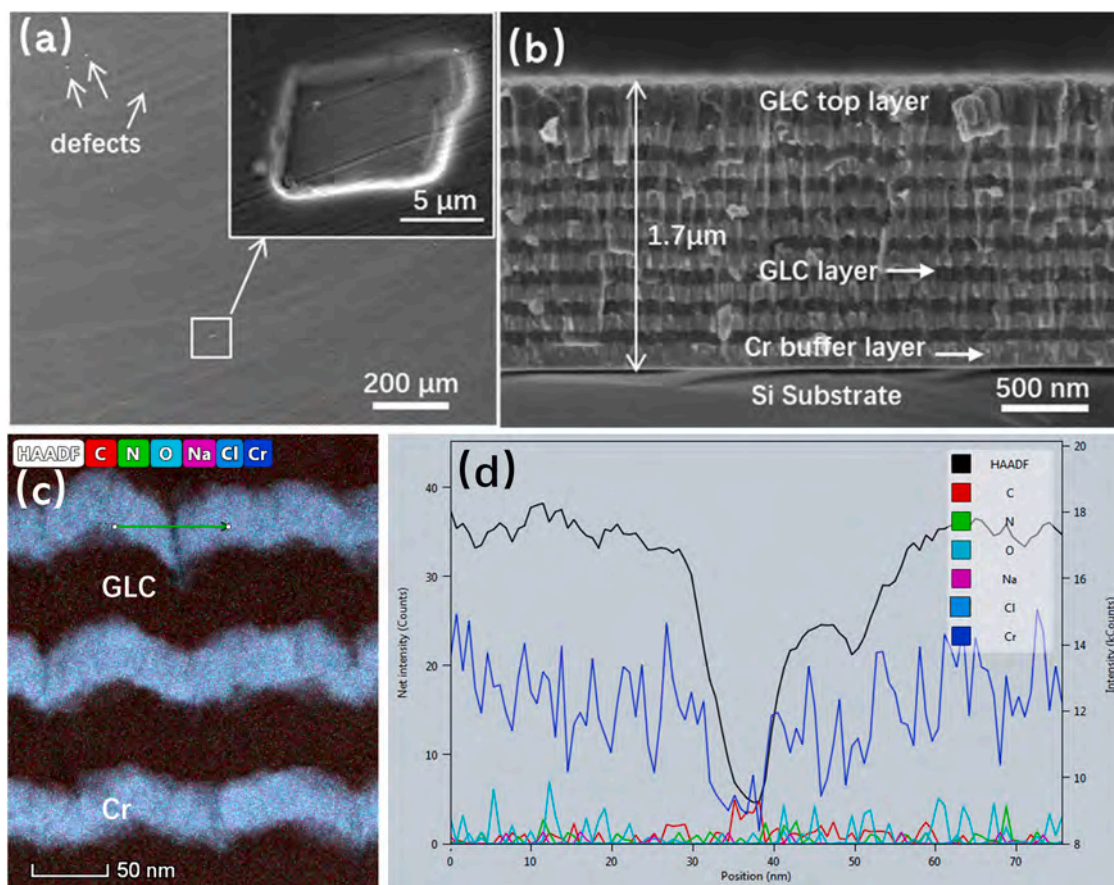
Fig. 2. The cross-sectional of the Cr/GLC multilayered coatings (a), the surface morphologies of the coatings and the defects (b), the TEM-HAADF image of the multilayered coating after immersion at 5942 m (c) and (d) the line-EDS results obtained from (c) within the green lines.

Fig. 2 presents the surface and sectional structural images of the as-deposited Cr/GLC multilayered coating. The coating surface is largely uniform with localized micron-scale imperfections (indicated by white arrows) as shown in Fig. 2a. On enlarged inspection, these defects are mainly penetrating holes that exposed the substrate material. The cross-sectional view (Fig. 2b) demonstrates that the coating consists of alternating layers of Cr and GLC, with a total thickness of 1.7  $\mu\text{m}$ . Small variations in the interlayer structure are presented due to the columnar growth of the underlying Cr transition layer. The structure of the immersed coating was analyzed additionally using the TEM-HAADF technique. The study revealed, (with particular emphasis on the columnar growth of the Cr layer indicated by the green line), significant undulations in the alternating structure of the coating. The line scan results provide clear evidence of localized Cr layer defects in this area. Further information on the interface structure and defect formation of the coating can be found in earlier research [15,16].

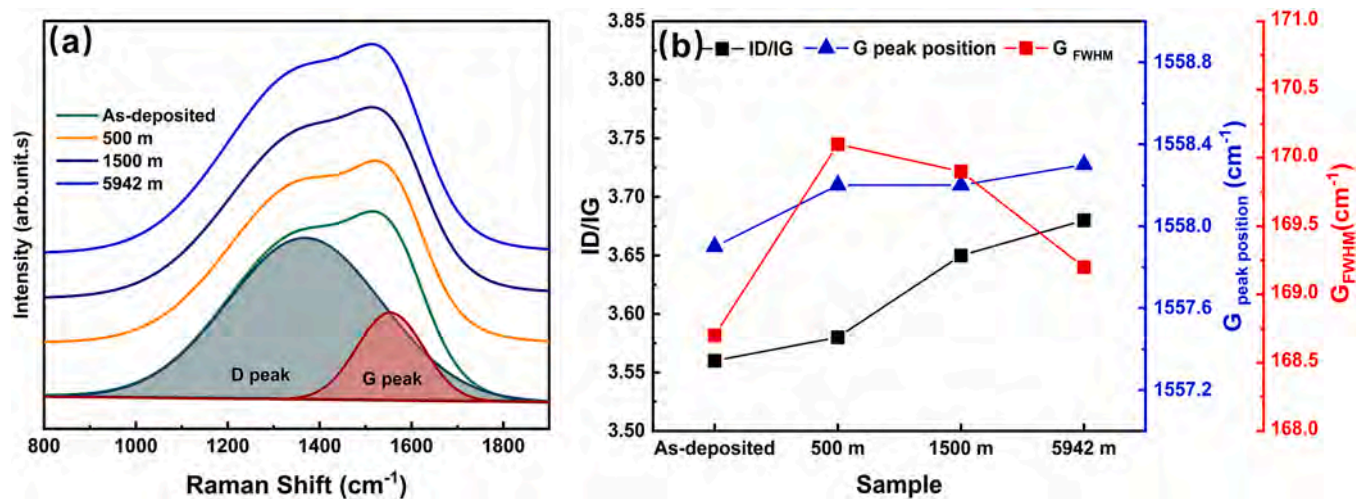
Fig. 3 presents the Raman spectra of the as-deposited Cr/GLC coating samples and the exposed coatings at different depths, along with the corresponding fitting results. The Raman spectra analysis of the Cr/GLC coatings, after exposure at different depths, reveals the presence of two broadened peaks within the range of 900–1800  $\text{cm}^{-1}$ . Through Gaussian fitting, it was discovered that all samples exhibited the characteristic of a strong D peak and a weak G peak, indicating the preserved structural features of typical graphitic coatings. From the fitting results, it is evident that the variation in the  $I_D/I_G$  ratio, representing the proportion of  $\text{sp}^2$  and  $\text{sp}^3$  hybridized states, exhibited only a minor increase, with values shifting from 3.55 to 3.63. Additionally, both the full width at half maximum (FWHM) of the G peak and the D peak didn't demonstrate discernible alterations. Previous research has indicated that amorphous carbon coatings may undergo corrosion reactions in corrosive environments with high chloride ion concentrations, leading to changes in their structural components [20]. However, the findings of this study suggest that in the deep-sea environment, amorphous carbon coatings did not undergo significant alterations in their structural components. Therefore, the protective performance of the coatings, in fact, primarily

Fig. 3. (a) The Raman spectra for Cr/GLC multilayered coatings after exposure under different depth in Pacific Ocean, (b) the corresponding fitted result of  $I_D/I_G$ ,  $G_{\text{position}}$  and  $G_{\text{FWHM}}$ .

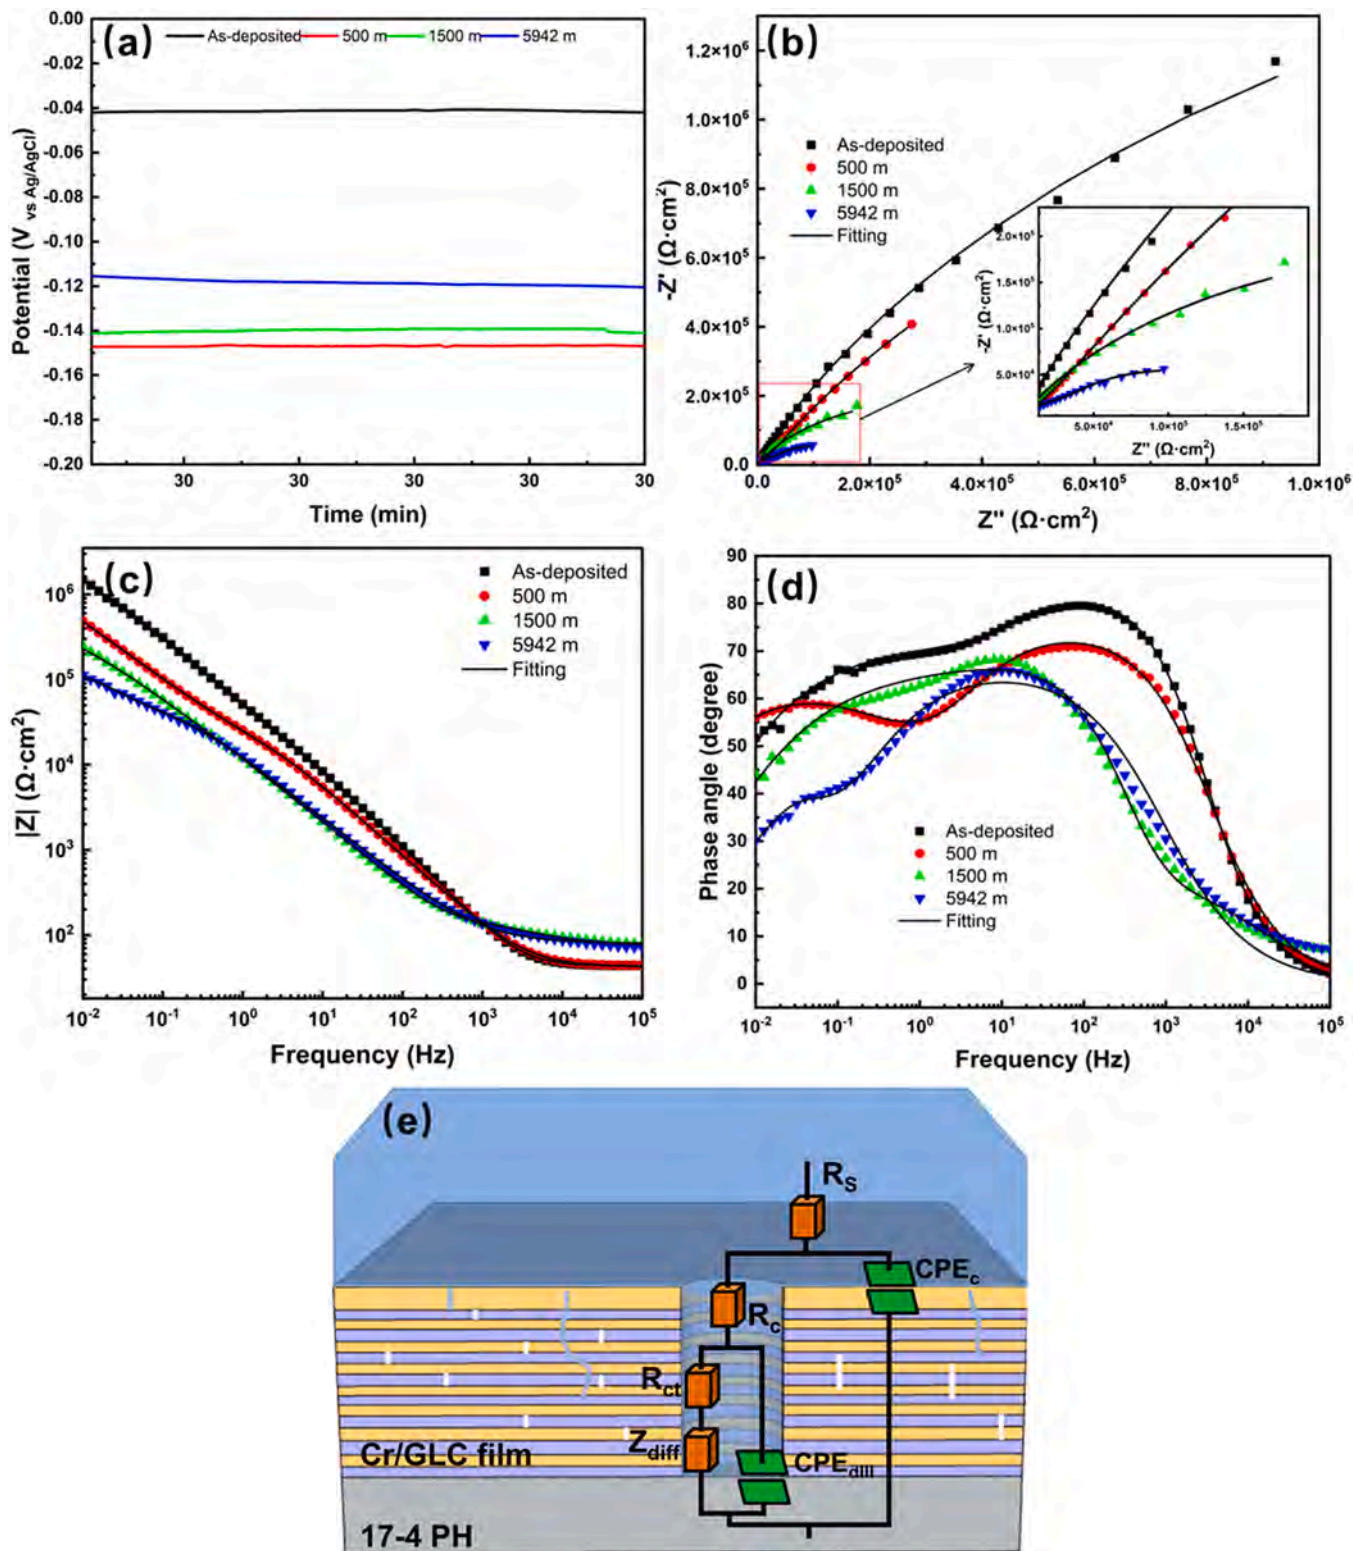
multilayered coatings after exposure at different sea depths, are presented in Fig. 8. From the changes of the OCP, the initial unexposed samples present OCP of  $-0.04 V_{Ag/AgCl}$ , while after immersion, the OCP values of the three sample types declined significantly to around  $-0.11 V_{Ag/AgCl}$  to  $-0.145 V_{Ag/AgCl}$ . As coating corrosion damage induced by deep-sea immersion is irreparable, OCP can be used as an

indicator of the level of damage caused by coating corrosion[23]. Lower OCP values demonstrate that the structure of the coating has been impacted, resulting in a reduction in its effectiveness to protect against corrosion on the substrate. From both the Nyquist plot and Bode impedance magnitude plot, the capacitive arc radius and the impedance magnitude at low frequency  $|Z|_{0.01 \text{ Hz}}$  of the samples have decreased

Fig. 8. The OCP values (a) and EIS results of Cr/GLC multilayered coating before and after an exposure in different depth at Pacific Ocean(b-d), the equivalent circuit used for fitting the EIS results (e).

substantially as compared to the as-deposited coating samples. The decrease is greater than one order of magnitude. This decline suggests that the coating's corrosion resistance has weakened significantly. The Bode phase angle graph indicates a gradual shift of the first phase peak towards lower frequencies accompanied by a decrease in peak value from roughly  $80^\circ$  to around  $63^\circ$  as immersion depth increases. Additionally, the phase angle drops to  $30^\circ$  in the most significant low-frequency range ( $<10$  Hz). The low-frequency phase angle variability, which represents local corrosion resistance, demonstrates a considerable deficiency in coating protection, in accordance with the observed corrosion morphology, which is attributed to localized coating delamination. The Bode plot characteristics reveal two distinguishable time constant features of the substrate/coating system. Incorporating processes such as interfacial corrosion product diffusion, the fitting was carried out utilizing the equivalent circuit depicted in Fig. 8e. Within this circuit,  $R_s$  represents solution resistance,  $R_{po}$  represents pore resistance,  $R_{ct}$  denotes charge transfer resistance, and  $Z_{diff}$  characterizes the diffusion behavior of a semi-infinite plane. A Constant Phase Element (CPE) was implemented as a substitute for the ideal capacitor component. The solid black line indicates that the fitting results match well to the measured results over most frequency ranges, with chi-square values ( $\chi^2$ ) within the order of  $10^{-4}$ , presenting a strong agreement between the chosen equivalent circuit and the actual EIS outcomes. Table 1 provides a summary of the fitting results.

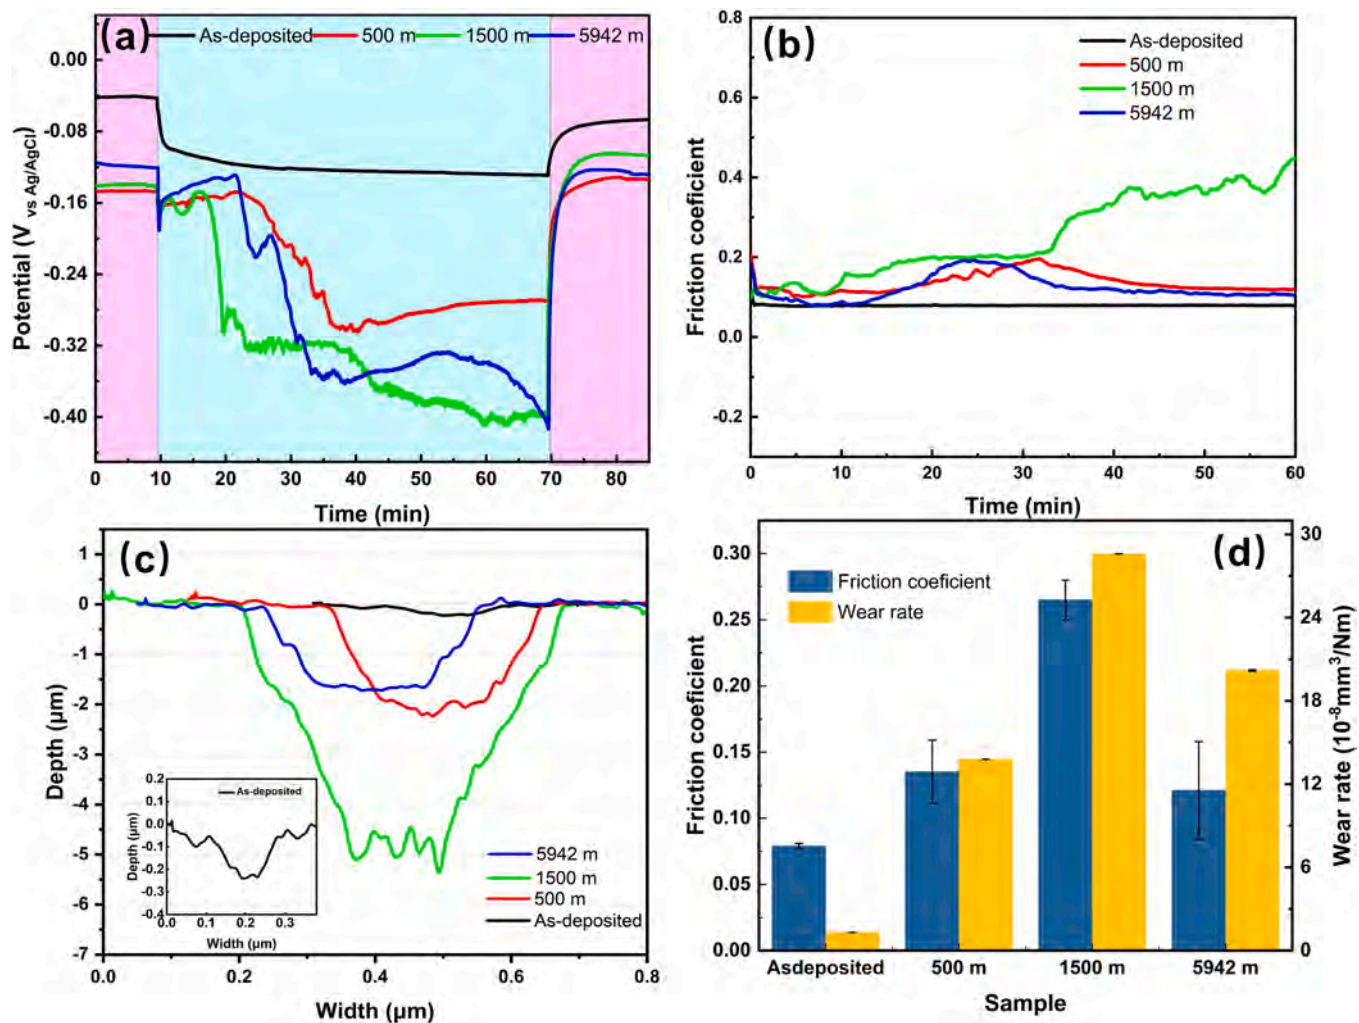
The coating samples showed extensive interfacial corrosion after immersion at various sea depths. This corrosion negatively affected the adhesion of the coating interface, and ultimately led to a reduced tribological performance (friction and wear) of the coating. To evaluate this effect, friction experiments were conducted under simulated seawater lubrication conditions. The results of the friction coefficient and wear rate are depicted in Fig. 9. Analysis of the monitoring data for Open Circuit Potential (OCP) revealed that the OCP immediately decreased upon sliding. OCP can reflect the ratio of the worn area to the intact area within the coating in the abrasion process [24]. The instantaneous decrease in OCP suggests that sliding process exposed more metal areas within the coating to the solution. In contrast, the samples deposited with original state showed only a minimal reduction of 0.05 V in OCP after sliding initiation, remaining stable until the end of the sliding test, when it returned to its initial level. This observation suggests that only minor damage was found in the as deposited coating during sliding. Additionally, the subsequent OCP recovery shows that exposed metal areas were able to repassivate swiftly.

dropped and then rose briefly before falling rapidly to its lowest point (from  $-0.42$  V to  $-0.3$  V) approximately 25 minutes into the test. This value approached the intrinsic value of the 17-4PH substrate, indicating total failure and delamination of the coating. The initial increase in OCP during the early stages of sliding was anomalous. This indicates the process by which the Cr/GLC multilayer coating filled the frictional interface due to delamination and abrasion, leaving the frictional interface relatively intact. In simple terms, the coating film was gradually ground into the friction interface by friction. This resulted in an increase in the OCP of the coating. Subsequently, as wear continued, the contact surface gradually exposed the substrate material. Following the frictional slip, all the coating samples exhibited a significant passivation phenomenon after immersion, with the OCP gradually recovering and even exceeding the initial value. This passivation phenomenon provides direct evidence of the exposure of the stainless steel substrate and the structural changes in the wear debris resulting from the friction process [25]. Correspondingly, the friction coefficients showed a comparable variation pattern. As shown in Fig. 9b, the friction coefficient curve for the as-deposited samples remained smooth and stable ( $\sim 0.09$ ), whereas the post-immersion samples experienced substantial fluctuations and increases. After roughly 10 minutes of sliding, all post-immersion samples gradually increased in the coefficient of friction (COF), surpassing the values seen for the as-deposited coating samples. Amongst them, the coating sample immersion in 1500 m achieved a COF value of up to 0.41, signifying the full detachment of the previously transparent surface coating. From the wear profiles shown in Fig. 9c, it is evident that the coatings immersed at different depths exhibit wear depths equal to or exceeding the coating thickness. In particular, the sample immersed at a depth of 1500 m shows a maximum wear depth of approximately 5  $\mu\text{m}$ , indicating complete delamination of the coating. Calculation of the wear rate shows that the coated samples exhibit wear rates after immersion that exceed those of the as-deposited coatings by two orders of magnitude, reaching a maximum value of  $2.76 \times 10^{-7} \text{ mm}^3/\text{Nm}$  (as shown in Fig. 9d). The significant deterioration in the mentioned tribological performance metrics clearly indicates a significant degradation in the wear resistance of the coatings induced by immersion at different sea depths.

Fig. 9. The monitored OCP value (a) and (b) friction curves during the sliding process of Cr/GLC multilayered coating during the sliding process, (c) the wear profiles of the coatings after the friction test and (d) the average friction coefficient and calculated wear rate.
